## Ultrasonic Thickness Inspection Report

<b>Client:</b>	Vause Oil Production Services Ltd.			<b>Location:</b>	Lion Nathan Brewery, Auckland City		
<b>Project:</b>	Air Receiver at Lion Nathan Brewery			<b>Order No:</b>	5191 dtd 26-Nov-10		
<b>Plant Name:</b>	Air Receiver at Lion Nathan Brewery			<b>Activity No:</b>	Not Applicable		
<b>Equipment Name:</b>	Air Receiver (Eqpt official no. 78284)			<b>Item Tested:</b>	Vessel wall thickness		
<b>Job Description:</b>	Thickness assessment of bottom of Air Receiver						
<b>Inspection Spec:</b>	N/A			<b>Acceptance Criteria:</b>	Report Findings		
<b>SGS Procedure:</b>	ITP402			<b>Welding Process:</b>	N/A		
<b>Surface Condition:</b>	Painted			<b>Heat Treatment:</b>	Not Specified		
<b>Material Type:</b>	Carbon Steel			<b>Equipment:</b>	DMS 2 S/N:AKL00YHF8		
<b>Nominal Thickness:</b>	Not Specified			<b>Test Blocks:</b>	Stepw edge		
<b>Technique:</b>	Single Spot - Single Measurement (SS)			<b>Couplant:</b>	Ultragel

Ultrasonic Thickness testing done to assess remaining thickness of Air Receiver (Equipment official no. 78284) on locations as detailed as below:

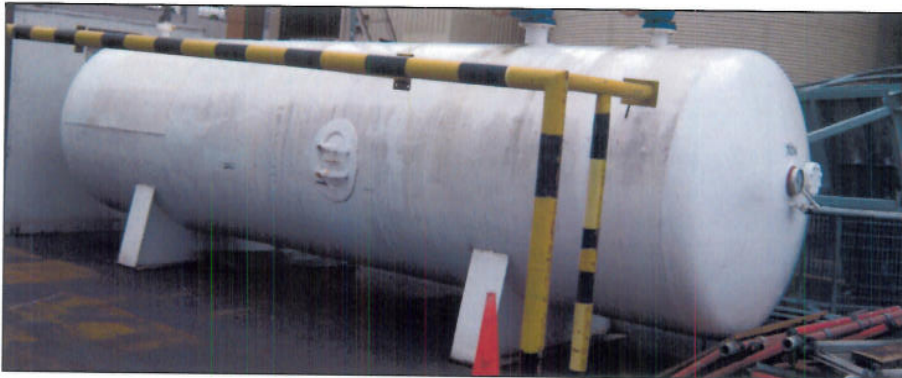
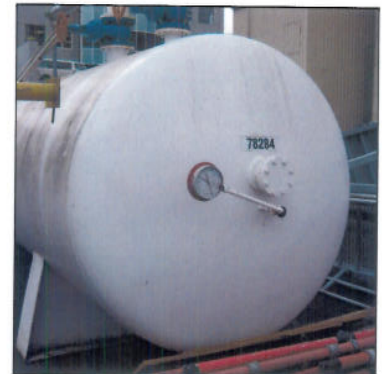
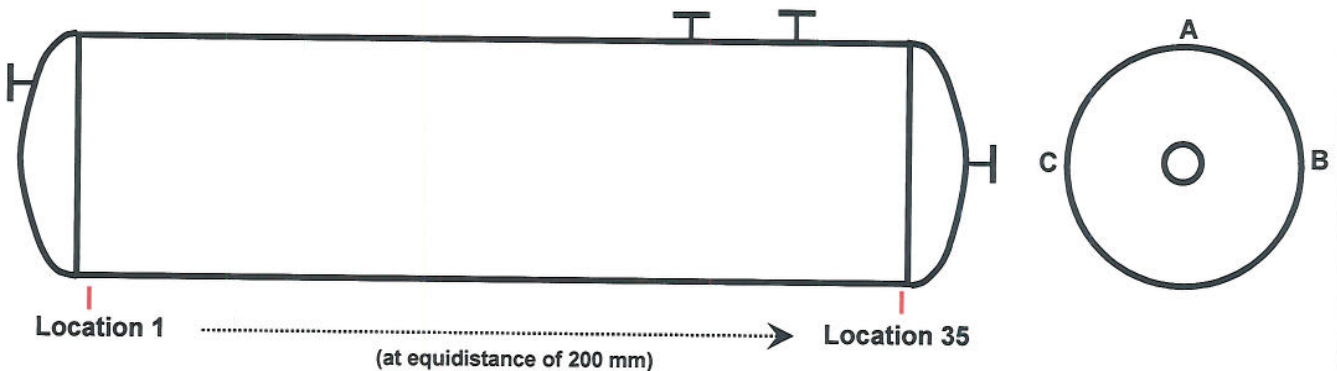
**1. Shell Thickness readings taken outlining following orientation and locations :**

Thickness readings noted on Orientation A, B & C from location 1 to 35 as below :

1	2	3	4	5	6	7	8	9	10	11	12
A	12.8	12.8	12.5	12.8	12.5	12.8	12.8	12.8	12.9	12.6	12.8	12.8
B	13.5	13.0	13.4	13.0	13.0	12.4	13.1	13.0	13.0	13.0	12.8	12.6
C	13.0	13.0	13.0	13.0	13.0	13.5	13.0	13.1	13.1	13.1	12.7	13.1

13	14	15	16	17	18	19	20	21	22	23	24
A	12.8	12.6	12.6	12.7	13.0	13.1	12.9	12.8	13.0	12.9	13.1	12.9
B	12.8	12.7	12.8	12.8	12.3	13.0	13.0	13.1	13.1	13.0	13.0	13.1
C	12.7	13.1	12.7	12.8	13.1	13.2	12.7	13.1	13.2	13.0	13.1	13.1

25	26	27	28	29	30	31	32	33	34	35
A	13.2	12.6	12.5	12.5	12.7	12.6	12.6	12.6	12.7	12.5	12.8
B	13.0	12.4	13.2	12.0	12.6	12.6	12.7	12.7	12.8	12.4	12.2
C	13.1	12.7	13.2	12.5	12.8	12.5	12.5	12.8	12.9	12.9	12.6

Minimum observed thickness readings shown in Yellow shade.  
Lowest found thickness shown in Blue shade

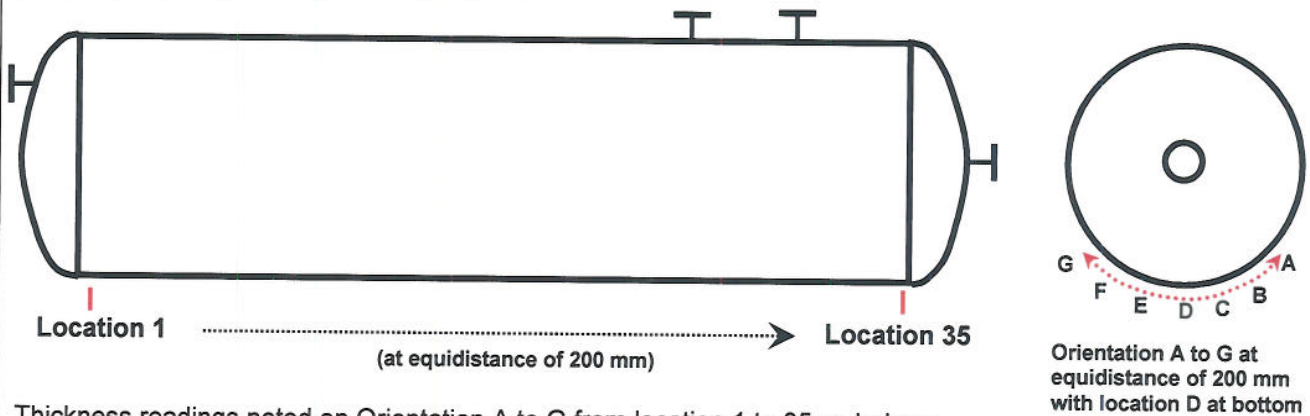
**2. Thickness assessment done on bottom band width of 1200 mm of the tank.**

Thickness readings noted on Orientation A to G from location 1 to 35 as below :

A	B	C	D	E	F	G
1	13.0	13.0	12.9	12.9	13.1	13.0	13.0
2	13.0	13.0	13.0	12.3	13.0	13.1	13.1
3	13.0	13.1	13.1	13.0	13.0	13.1	13.1
4	13.0	13.1	13.0	12.9	12.8	13.1	13.1
5	13.0	13.1	13.1	12.9	12.8	13.1	13.1
6	13.0	13.0	13.1	12.8	12.7	13.1	13.1
7	13.0	13.1	13.1	12.8	12.9	13.1	13.1
8	13.0	13.0	12.5	12.9	13.0	13.1	13.1
9	13.1	13.1	12.9	13.0	13.1	13.0	13.1
10	13.4	13.0	13.0	13.0	13.0	13.1	13.0
11	12.9	12.9	12.9	12.9	12.9	12.9	12.8
12	12.9	12.9	12.9	12.6	12.6	12.5	12.8
13	12.9	12.9	12.9	12.7	12.9	12.8	12.8
14	12.9	12.9	12.8	12.8	12.9	12.8	12.3
15	12.9	12.9	12.8	12.7	12.9	12.2	11.8
16	12.8	12.8	12.8	12.8	12.8	12.8	12.6
17	12.9	13.0	13.0	12.4	13.0	13.1	13.1

A	B	C	D	E	F	G
18	13.0	13.0	13.0	13.0	12.9	13.1	13.1
19	13.1	13.0	13.0	13.0	13.1	13.2	13.2
20	13.1	13.0	13.0	12.1	13.1	13.2	13.1
21	13.1	12.6	13.1	13.0	13.1	13.1	13.1
22	13.1	13.0	13.0	13.1	13.1	13.1	13.2
23	13.1	13.0	13.1	13.1	13.1	13.2	13.2
24	13.1	12.4	13.1	13.0	13.0	13.2	13.2
25	13.1	12.5	12.1	13.0	13.1	13.2	12.8
26	12.6	12.7	13.2	12.7	12.8	12.8	12.8
27	12.5	12.5	13.2	12.1	12.9	12.9	12.9
28	12.6	12.6	12.7	12.7	12.3	12.9	12.9
29	12.6	12.5	12.7	12.8	12.9	12.9	12.9
30	12.6	12.7	12.4	12.8	12.9	12.9	12.9
31	12.7	12.6	12.3	12.8	12.9	12.8	12.7
32	12.8	12.8	12.7	12.8	13.0	12.6	12.9
33	12.7	12.8	12.8	12.9	12.4	13.4	13.0
34	12.7	12.8	12.8	12.9	13.0	13.0	13.0
35	12.7	12.8	12.8	12.8	13.0	13.0	13.0

Minimum observed thickness readings shown in Yellow shade.

Lowest found thickness shown in Blue shade

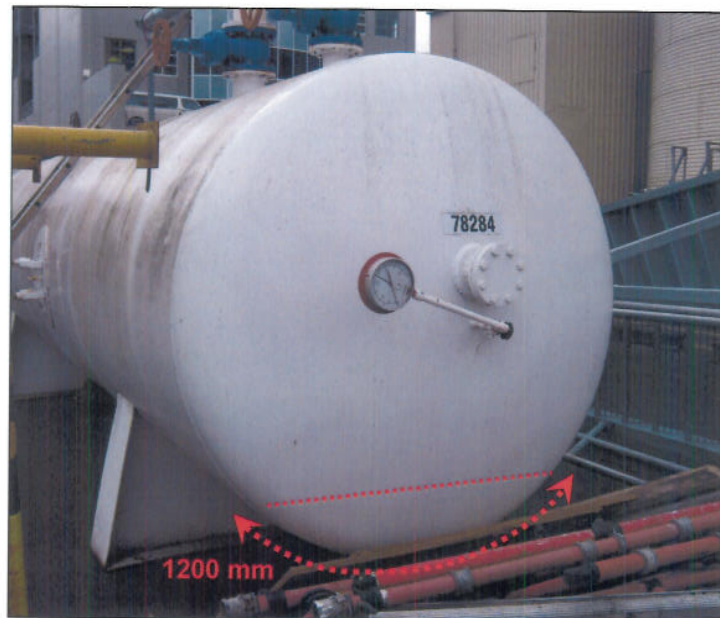
RHS Dome

Thickness found between **16.1 to 16.5 mm**

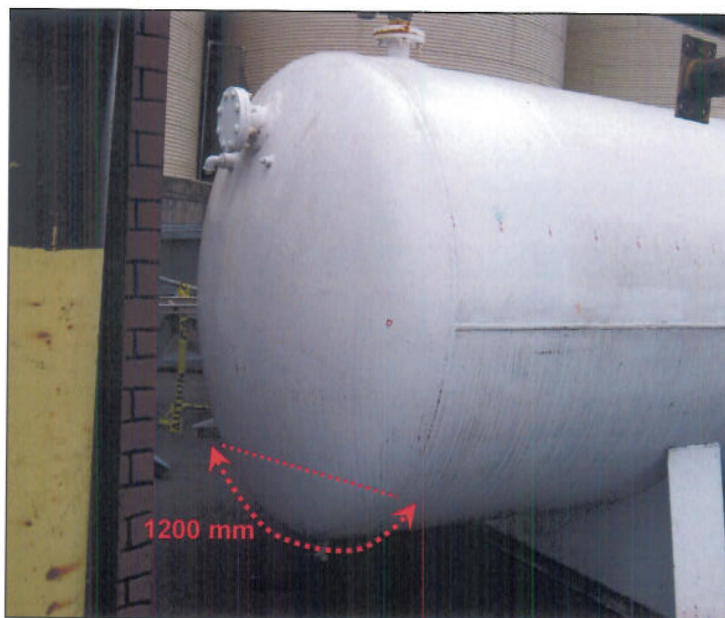
LHS Dome

Thickness found between **16.1 to 16.7 mm**
